Implementation of results of visitor and environmental impact monitoring: an example of Kauksi campsite of the recreation area along the northern coast of Lake Peipsi of Estonian State Forest Management Centre

Anu Almik, Kaidi Maran, Kalle Karoles and Marge Rammo

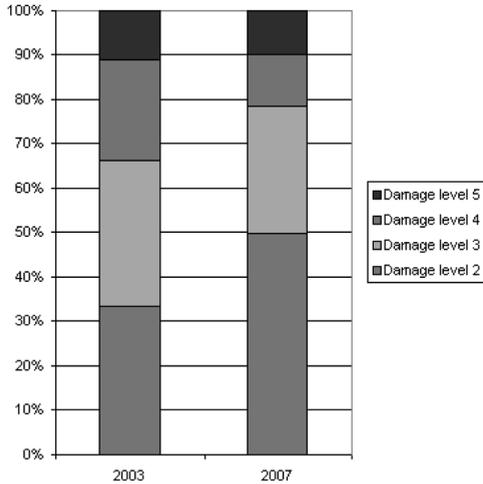
Fig. 1 Proportion of area with different soil and ground vegetation damage in Kauksi campsite in 2003 and 2007. Damage level 2 marks an area with ground vegetation. Damage level 5 denotes an area with bare mineral ground and partly with erosion.

In 2003 environmental impact assessment was conducted in the area, its results revealing that the impacts cause excess of the limits of acceptable change. So the proportion of area with vegetation loss due to trampling was 33,6 %. The proportion of area with bare mineral ground and partly with erosion was 10,9 %. Anthropogenic damages were found on 25 % of dominant-story pines.

In 2007 a repeat survey was conducted at Kauksi campsite, which showed that as a result of the implemented measures environmental status in the area had considerably improved, especially as regards ground vegetation and natural regeneration of trees and the recovery of understory. The share of area with vegetation loss due to trampling had decreased by 12,1 per cent compared to the year 2003. The proportion of area with bare mineral ground and partly with erosion was 9,9 %, down by 1 %, despite the continued use of the area. New anthropogenic damages occurred on only 1,3 % of the pines of the dominant story. The total number of

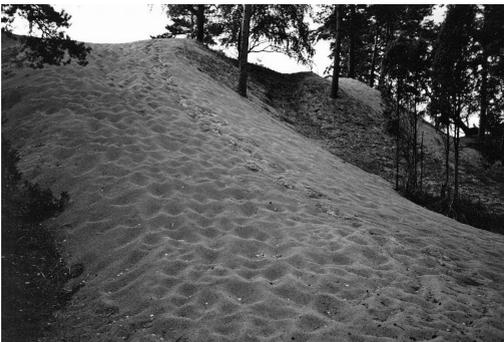
Fig. 2. The state of the highest dune in 2003

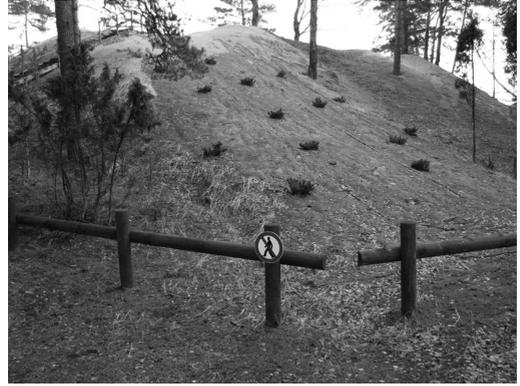
Fig. 3. The dune slope facing the campsite was covered with geotextile and mountain pines were planted on the slope

Appropriate infrastructure was constructed for the protection of the dunes between the campsite and the lakeshore, and soil protection works were performed. In the years 2006-2007 stairs were made on the highest dune both on the side of the campsite and on the side towards the shore and a small wooden observation platform was built on the dune ridge. The dune slope facing the campsite was covered with geotextile and mountain pines were planted on the slope. At the foot of the dune side facing the campsite a log rail was constructed, and signs prohibiting climbing and a stand with necessary information were installed. Boardwalks were made on the four paths from the campsite over the dunes to the lakeshore.

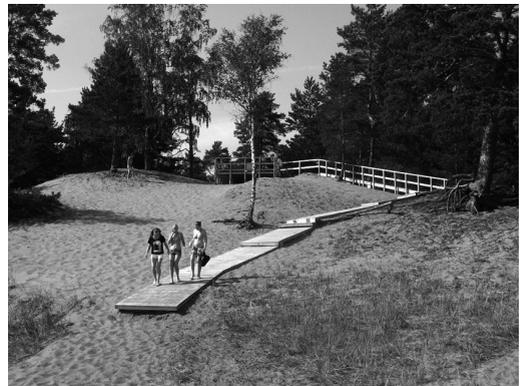
Fig. 4. Boardwalk and observation platform for dune protection
